PROPERTY INSPECTION REPORT

Address: SomewhereTexas

By: Jack Shouse TREC # 21100

11/5/2014

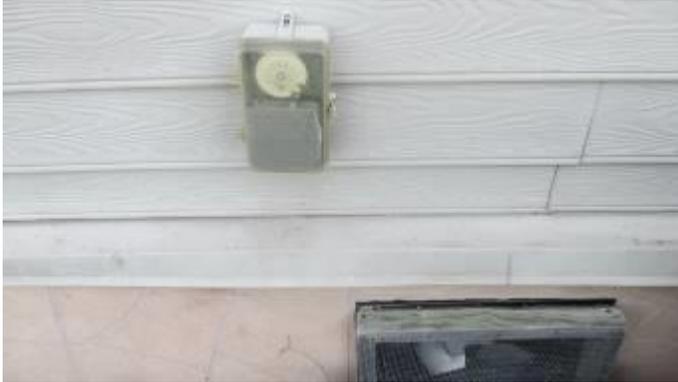
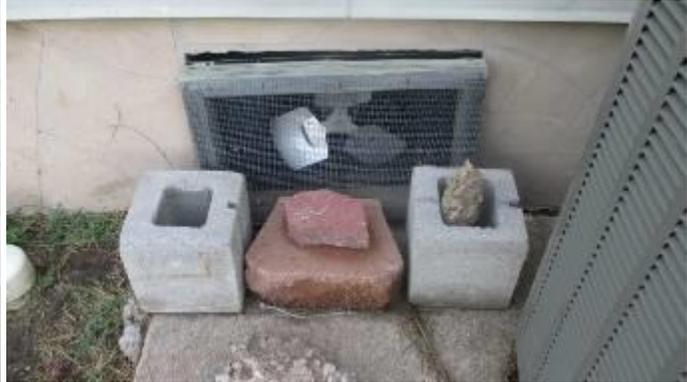
Comments: The foundation appears to be functioning as intended. The crawl space ventilation is supplied by a timed fan in the West end of the foundation. It runs for 2 hours daily. By today's standards there should be a vent within 3 feet of each corner in a crawl space.

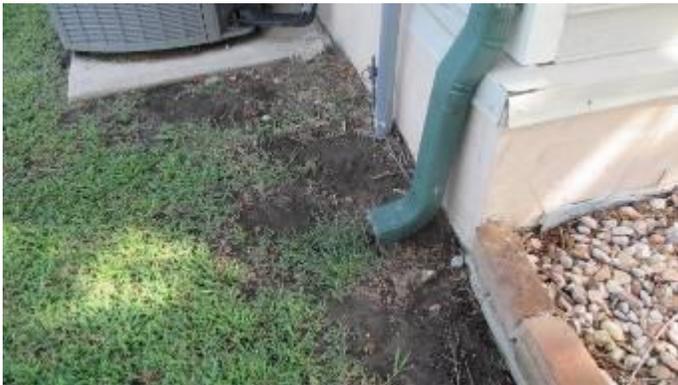
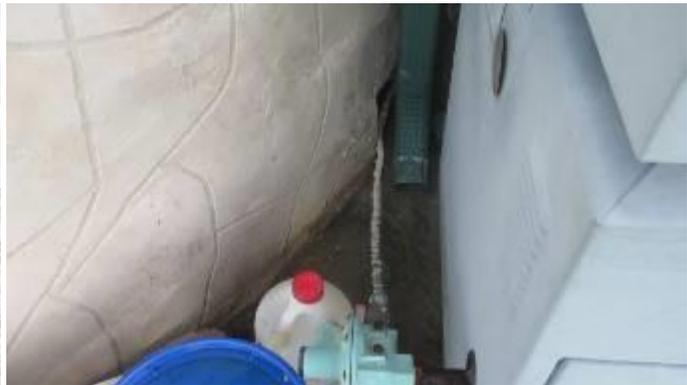
B. Grading & Drainage – Comments: The gutter extensions are not connected on the West end of the house. The pool pump area should be made to drain away from the house.

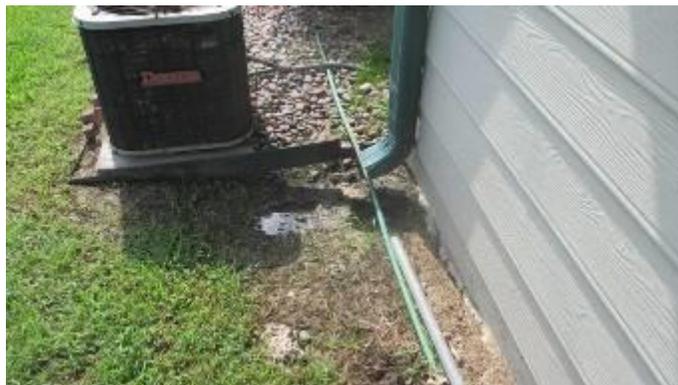
Air condenser behind garage should be leveled to prevent damage to the pump. The gutter should be extended to move the rain water away from the building.

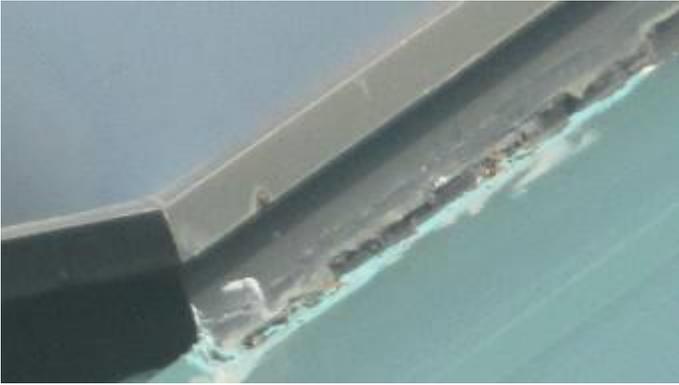
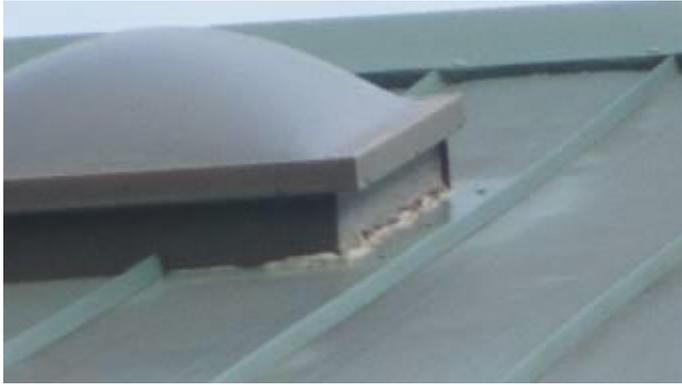
Comments: The skylights do not appear to be leaking at this time but I do recommend to get them re-caulked by a roofing contractor

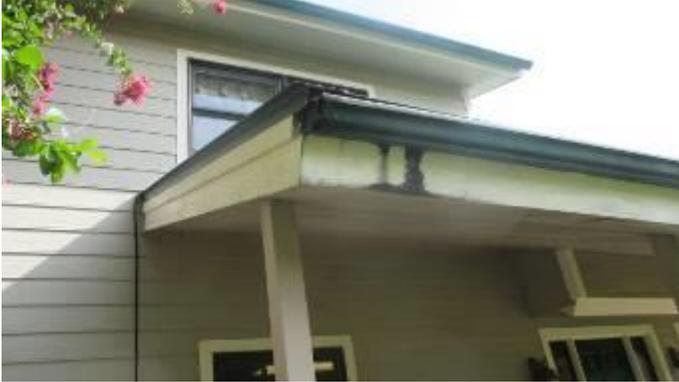
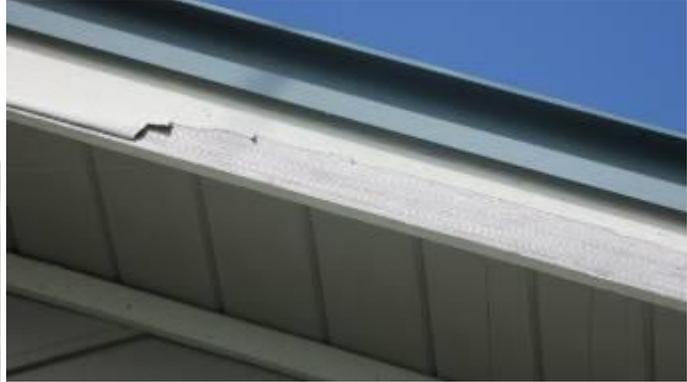
E. Walls (Interior & Exterior) – Comments: The gutter on the front porch is not draining properly and is causing damage to the fascia board. Paint is very thin and chipping on the fascia board on garage office which will lead to moisture damage if not repaired.

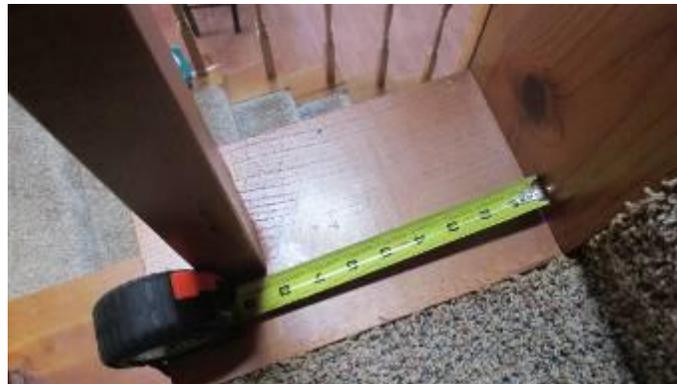
I. Stairways (Interior & Exterior) – Comments: For child safety reasons the maximum distance between stair rail bannisters should be no more than 4 inches.

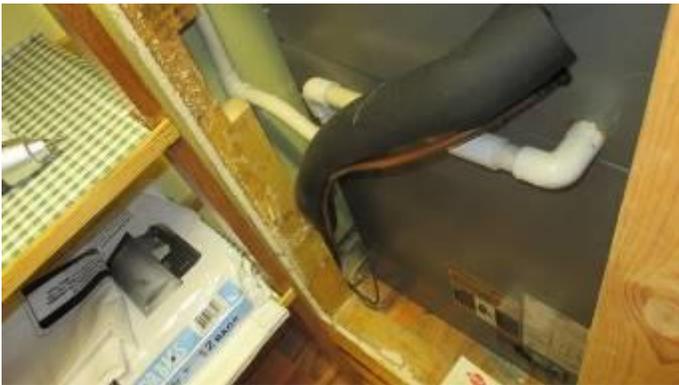
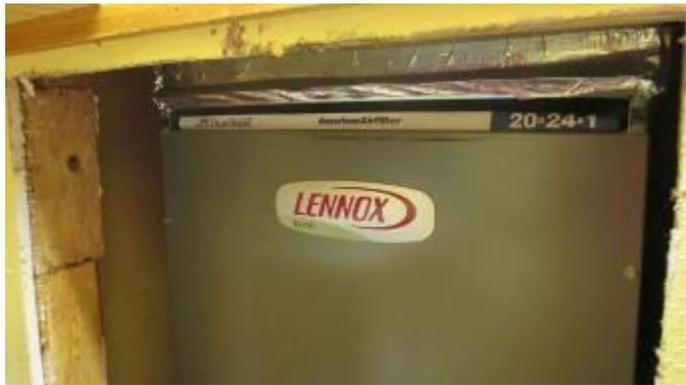
Comments: The main downstairs air conditioning cooling differential between the return and the outlet register was only 8 degrees which normally should be between 14 to 21 degrees. I recommend to have it serviced by a licensed and insured HVAC contractor. Note; The downstairs air handler is in the pantry in the kitchen.

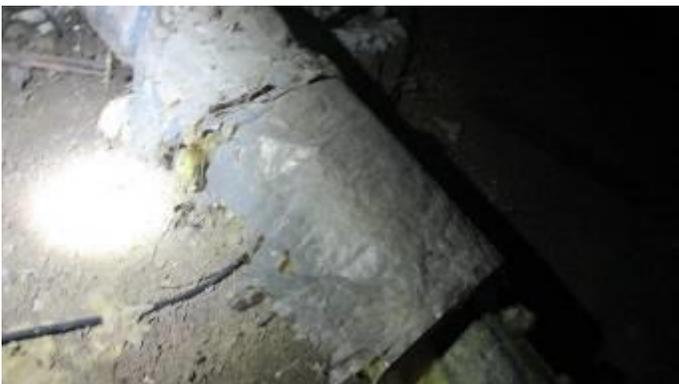
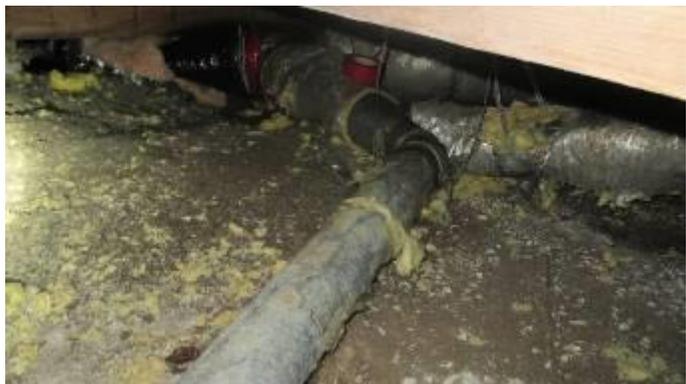
C. Ducts: The air ducts under the main living area had a lot of insulation falling off. Probably contributing to the deficient cooling in this area.

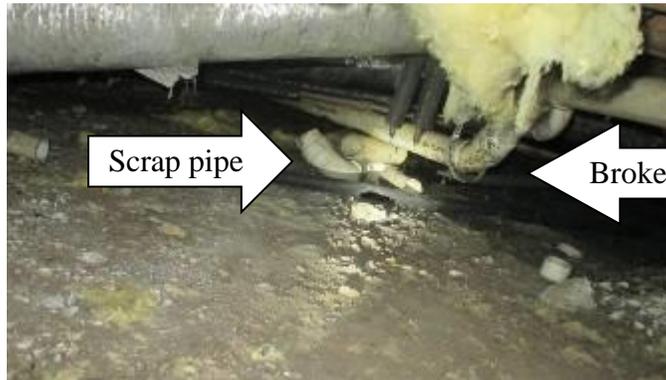
C. Drains, Wastes, and Vents – Comments: Support straps broken lose on the toilet line under the hall bath and is currently supported by scrap pipe.

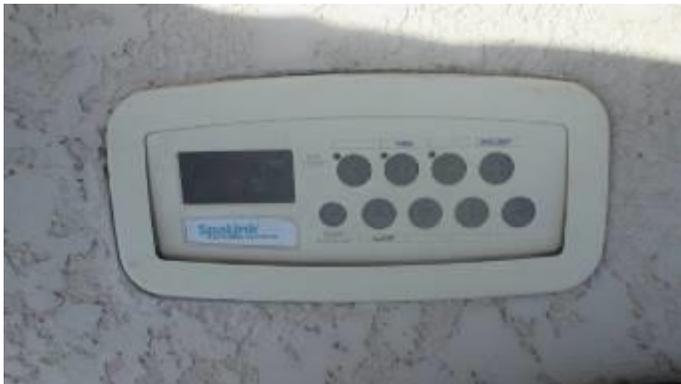
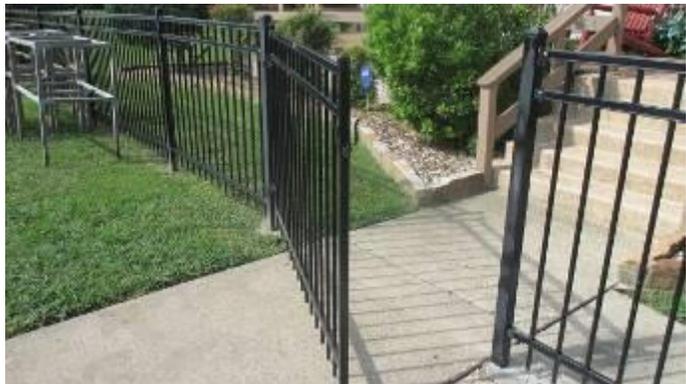
B Swimming Pools, Spas, Hot Tubs, and Equipment: The remote control in the deck floor near the spa is disconnected due to varmints. The gate to a pool area should be self-closing and self-locking for child safety. All doors exiting to the pool area should have a distinct alarm for child safety. Unable to verify the blower works as the delay to come on was 30 minutes.

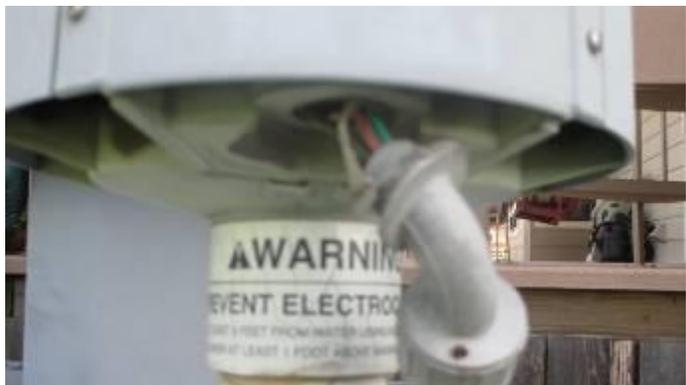
Blower electrical connector loose

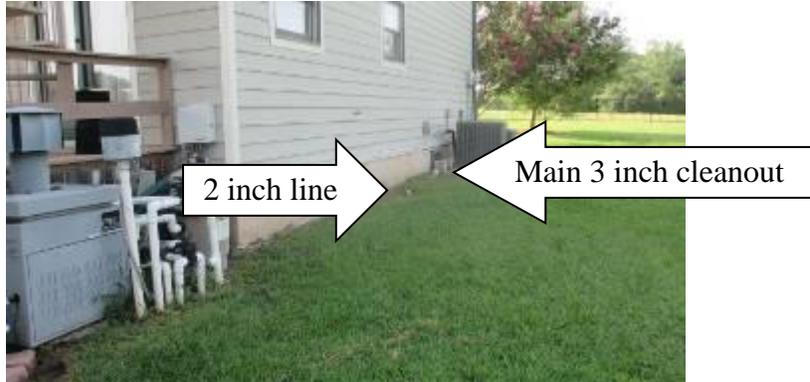
E. Private Sewage Disposal (Septic) Systems: The anaerobic (Old System) has not been pumped in 2 to 4 years and I recommend it be cleaned. The homeowner advised that the "Gray Water" which is everything but the toilets is running down the hill to a low area. All home drains should be treated in the septic system and I recommend that the 2 inch Gray Water drain be connected to the main septic system and the main system be enlarged if necessary by a licensed plumber or a licensed waste water system installer.
