PROPERTY INSPECTION REPORT

Address: SomewhereTexas

By: Jack Shouse TREC # 21100

11/5/2014

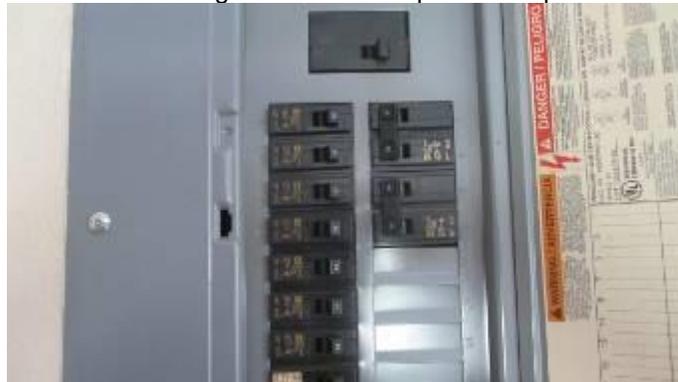
Garage Office 100 amps service panel
